Inspection Report

123 Main Street
Cincinnati OH 45140

Cincinnati Certified Home Inspections, LLC

Date: 4/15/2017	Time: 12:00 PM	Report ID: 17000
Property: 123 Main Street Cincinnati OH 45140	Customer: Mr. New Homeowner	Real Estate Professional:

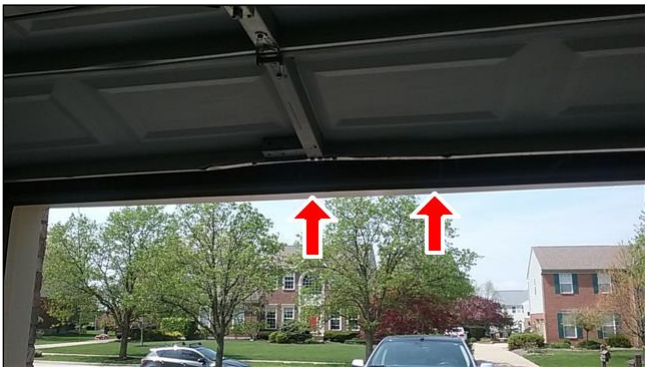
4.5 Item 1(Picture) Garage Doors

4.5 Both of the automatic doors have some minor damage on the bottom of the door. They do close properly.

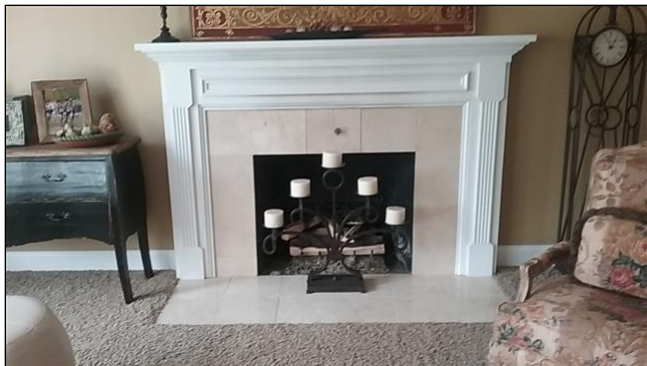
12.7 Item 1(Picture) Gas Fireplace

12.7 This fireplace has not been used for a while. Recommend having it serviced and cleaned prior to use. Safety issue.

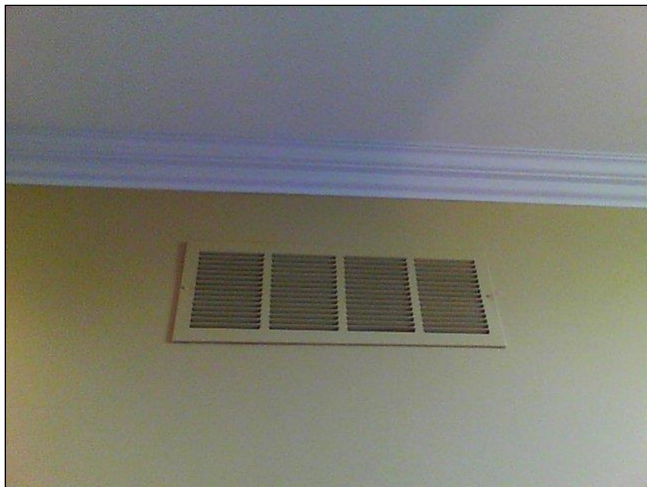
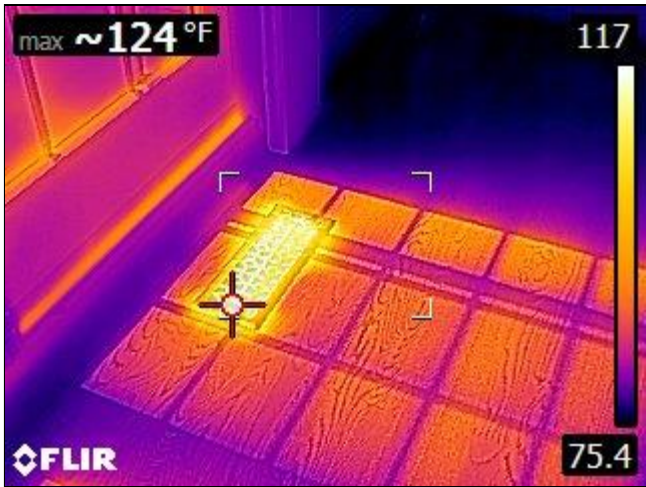
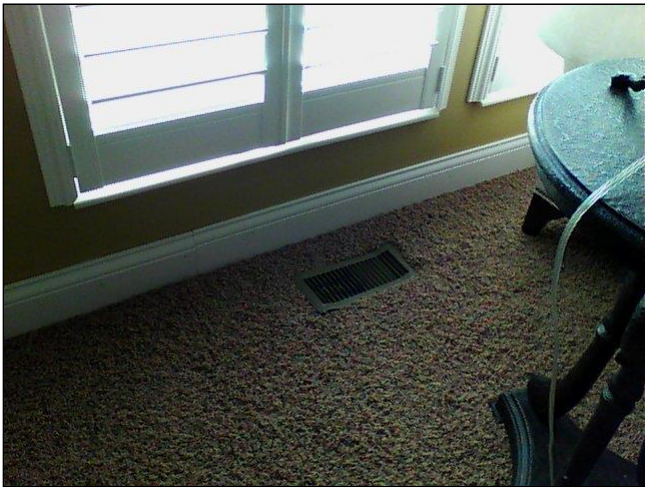
12.8 Item 1(Picture)

12.8 The ambient air test was performed by using a thermal camera on the air handler to determine if the difference in temperatures of the supply and return air are between 14 degrees and 22 degrees which indicates that the unit is heating / cooling as intended. The supply air temperature on your system read 79.5 degrees, and the return air temperature was 124 / 51.3 degrees. This indicates the unit is operating properly.

12.8 Item 2(Picture) Supply Air

12.8 Item 4(Picture) Return Air (Heat)

12.8 Item 6(Picture) Return Air (Cool)

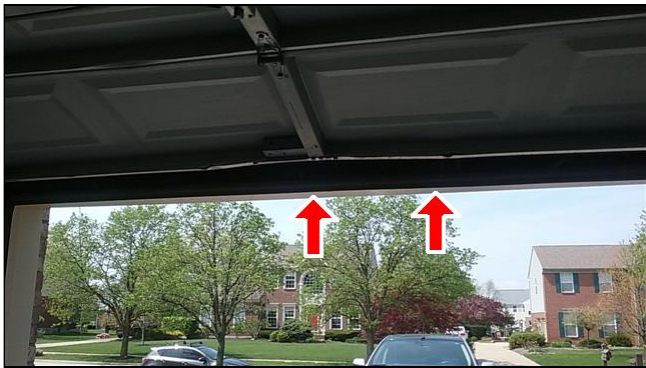
4.5 Item 1(Picture) Garage Doors

Both of the automatic doors have some minor damage on the bottom of the door. They do close properly.

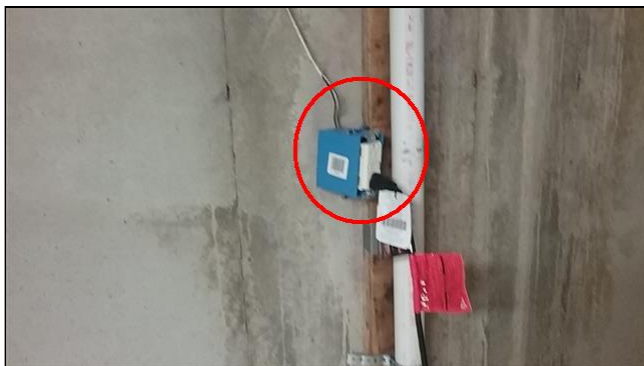
11.3 Item 1(Picture) Sump Pump Outlet

The outlet for the sump pump needs to be properly installed on the wall. It also needs a cover plate.

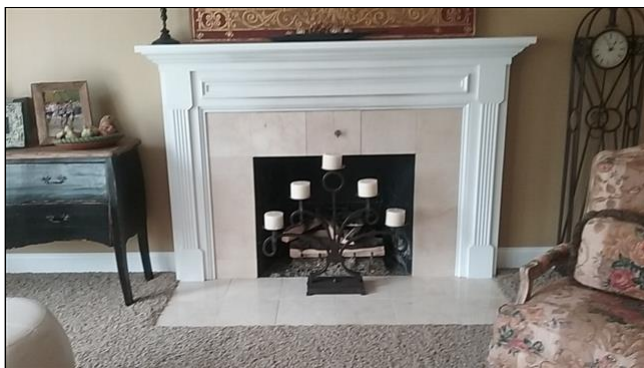
12.7 Item 1(Picture) Gas Fireplace

This fireplace has not been used for a while. Recommend having it serviced and cleaned prior to use. Safety issue.
